Client: John Smith

Report #: Sample 2010

123 U S Highway 45
Dyer, IN 46311

The Inspector Inc.
254 Burlington Beach Road
Valparaiso, IN 46383
(219)465-1785 Fax #:(260)818-2266

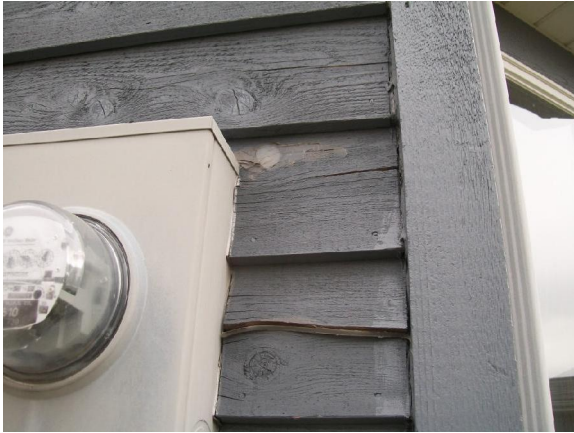
Component	Comments
Exterior Walls	<p>The house is of wood frame construction with wood siding at the exterior; the wood siding has evidence of weathering and deterioration at the south wall.</p> <p>See the Maintenance Section of this report for additional comments.</p>
Miscellaneous Exterior	<p>The concrete driveway was inspected and found to be in serviceable condition.</p> <p>The grading around the house appeared to slope away from the foundations properly.</p> <p>See the Maintenance Section of this report for additional comments regarding the exterior components.</p>
Basement Foundation	<p>The house is constructed on cast-in-place concrete foundation walls with a full basement. The foundation walls were covered with insulation or interior finishes; the condition of the concealed foundation walls could not be determined. The exposed portions of the foundation walls appeared to be in serviceable condition.</p> <p>See the Maintenance Section of this report for additional comments regarding common cracks at the foundation walls.</p>

Structure
Exterior Walls
Deteriorated wood siding

Component	Comments
Exterior Walls	The siding is weathered and deteriorated at several locations, especially on the south wall. Minor repairs and replacement of some of the siding is recommended.
Grading	The landscaping is in contact with the exterior wall; keeping all vegetation trimmed 18-24 inches away from the exterior wall is recommended to prevent damage, moisture, or pest intrusion into the exterior wall.
Foundation	Common cracks were visible at the foundation walls in one or more locations; no stains were visible at the cracks indicating moisture intrusion. Monitor for future moisture intrusion and contact a foundation waterproofing contractor for epoxy injection or repairs as needed.
Miscellaneous Exterior	Downspout extensions are recommended to divert the roof water away from the foundations. The paint or finish on the deck has signs of weathering, peeling, or deterioration; re-finishing of the deck is recommended. The gutter is damaged at the northwest corner of the house; consider replacement of the gutter during future repair work.

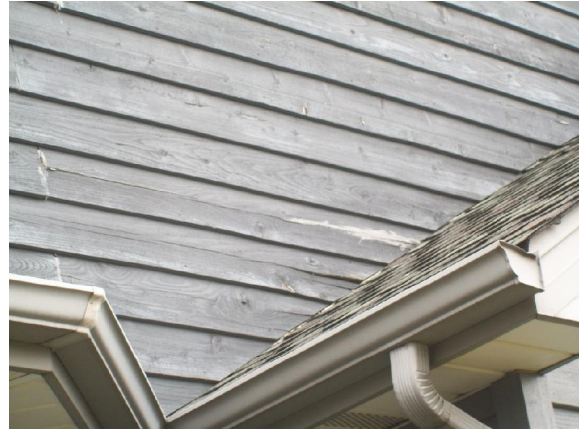
Structure
Exterior Walls
Deteriorated wood siding

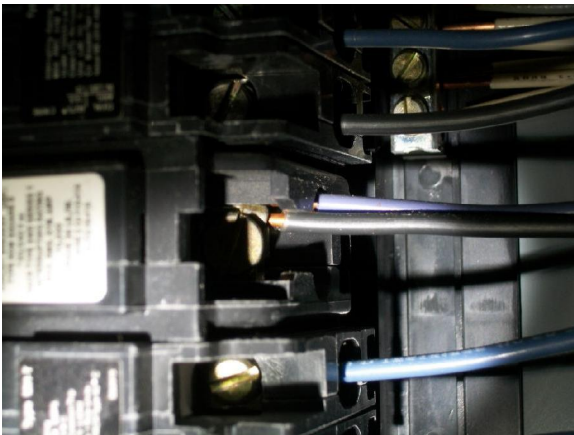
Electrical
Panel Notes
Double tap at main electrical panel

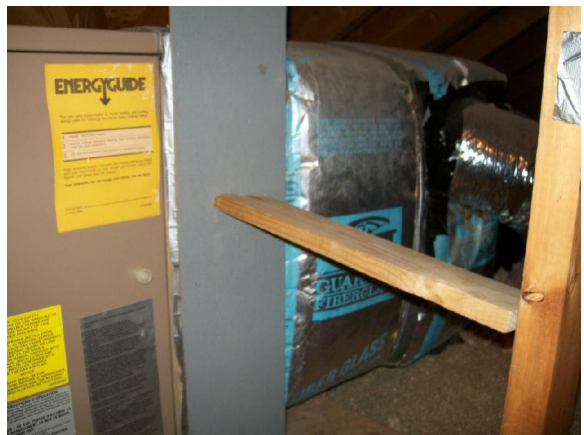
Heating
Air Filters
Temporary means of sealing off filter

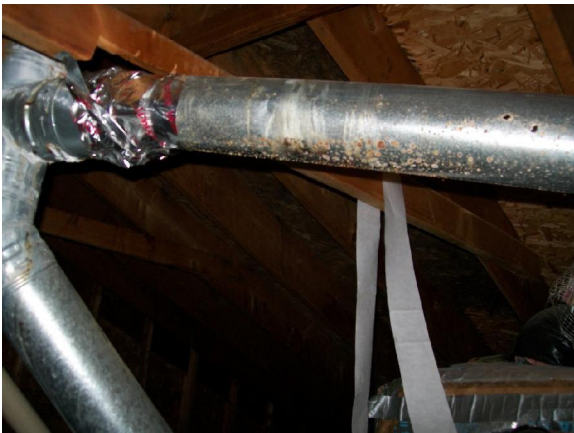
Heating
Venting
Deteriorated flue pipe in attic

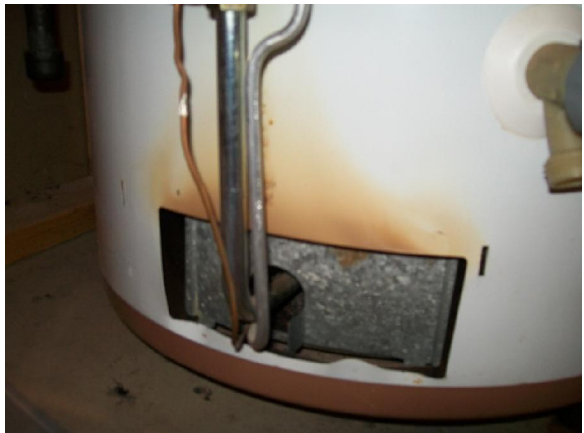
Component	Comments
Water Heater Condition	<p>The water heater has evidence of backdrafting at the burner chamber; this may be related to the deteriorated flue in the attic and at the roof. See the furnace venting section of this report for repair recommendations to the flue pipe in the attic.</p> <p>Although functional at the time of the inspection, the life expectancy of a conventional water heater is 8-10 years; budget for replacement soon.</p>

Plumbing
Water Heater Condition
Backdrafting at water heater in basement

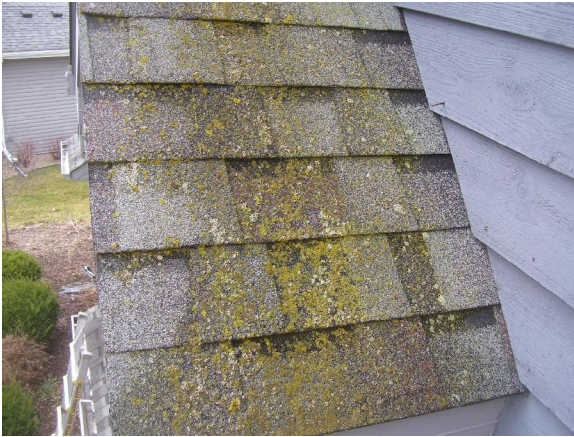
Wear indicators are present as follows; granule loss and moss.

Roof
Roof Conditions
Moss is present on north side

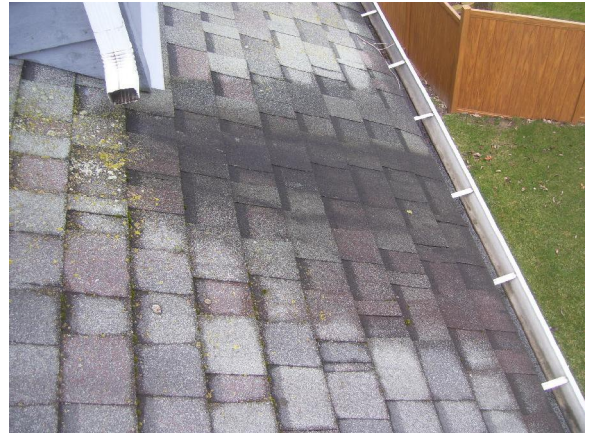
Roof
Roof Conditions
Accelerated wear due to downspout on north side

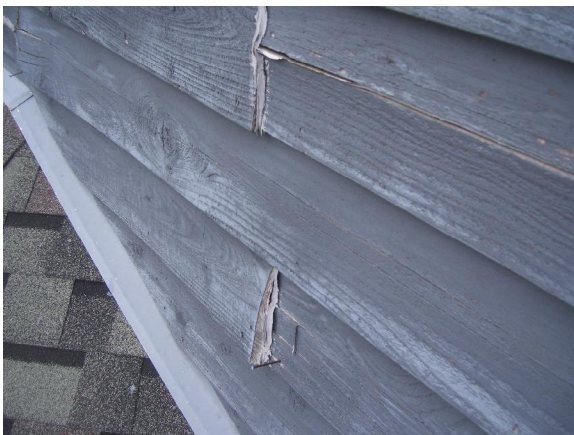
Structure
Exterior Walls
Deteriorated siding

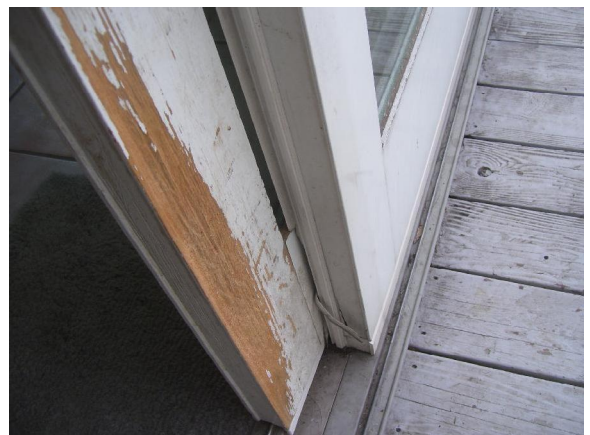
Interior	The basement sliding patio door appears to be off of the bottom track; the door would not shut or latch properly, creating a potential security issue. Repairs or adjustment of the door is recommended.
Bathrooms	A GFCI receptacle is present but is not functional at the Master Bath dressing table. Recommend replacement of the GFCI.

Interior
Doors/Windows
Deteriorated patio door

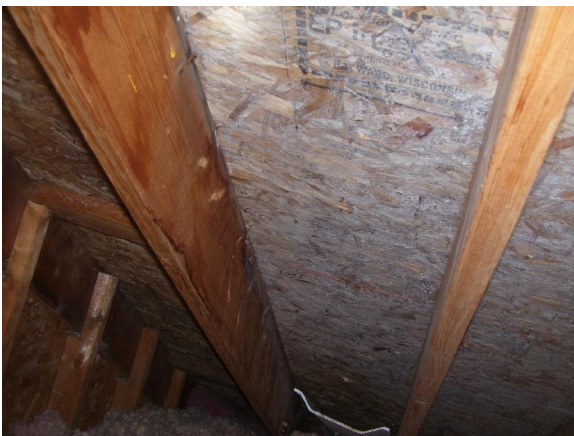
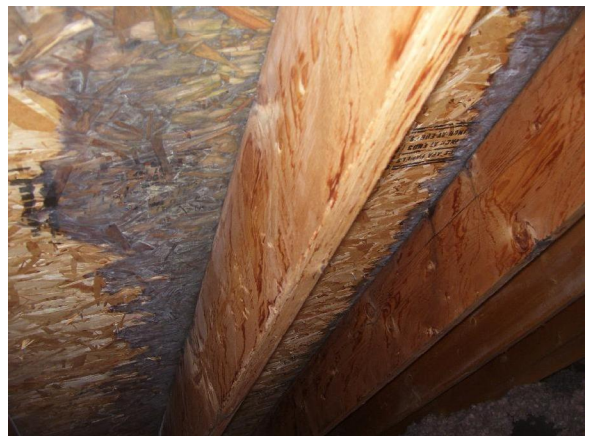
Discoloration of a minor portion of the roof sheeting or framing is indicative of possible microbial growth. This condition appears to be isolated to the area near the furnace vent and vent termination. Evaluation by an environmental contractor is recommended if allergies to mold are of particular concern.

Interior
Ventilation & Insulation
Mold like substance present in attic

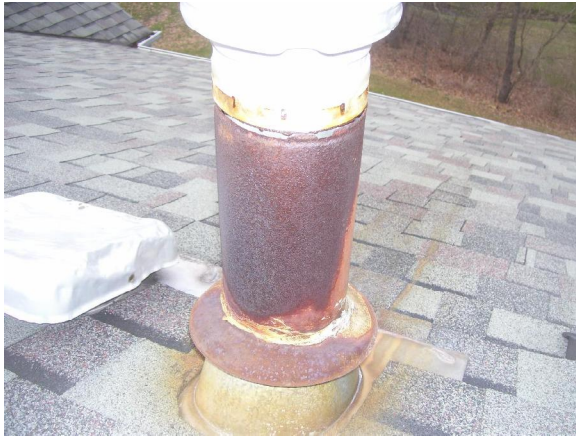
Natural gas equipment including the furnace and/or water heater is vented using a Type B Gas Vent. The vent is deteriorated at the roof termination. Recommend replacing the vent termination.

Roof
Chimney
Deteriorated vent at roof termination

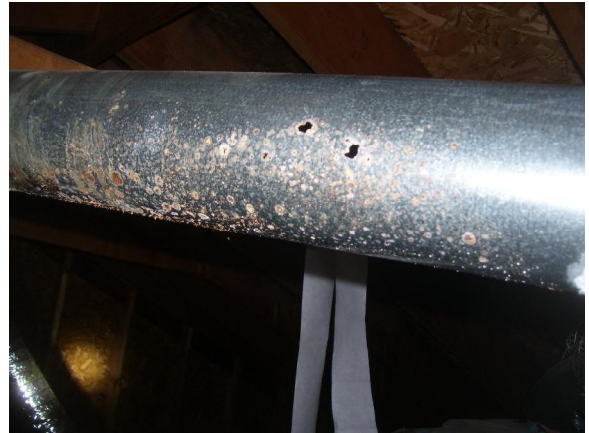
Heating
Venting
Deteriorated vent in attic

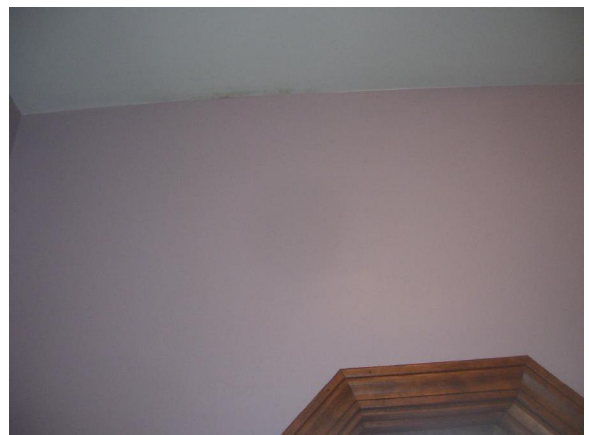
Interior
Walls/Ceilings/Floors
Stains noted on Master Bathroom ceiling
